**BUILDING
INSPECTOR
NELSON**

Building Inspection Report

Encompassing NZS 4306:2005

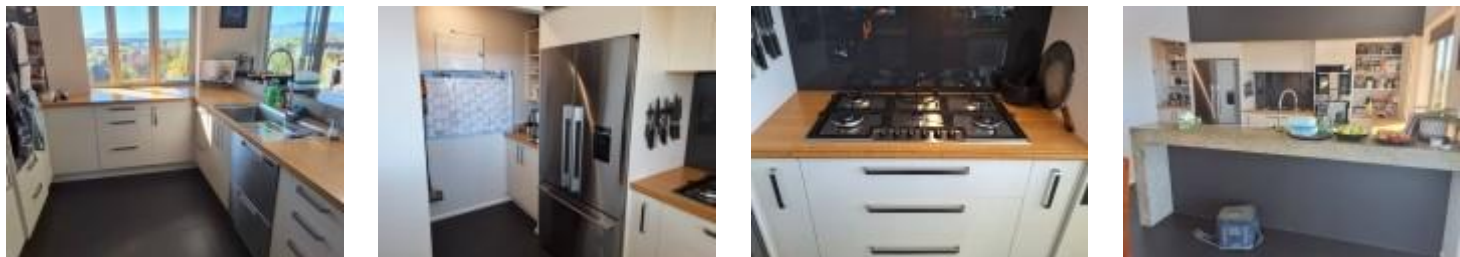
Kitchen 1

Comments	<p>The kitchen is in good working order, with all fittings functioning well. The only minor issue is one cupboard door that needs a slight adjustment to close properly. There is also a small amount of mould behind the sink, likely caused by water splashing during nightly dishwashing.</p> <p>Kitchen spout in good working order with no signs of moisture in wet area and under sink.</p> <p>Bifold window in good working order.</p>
----------	---

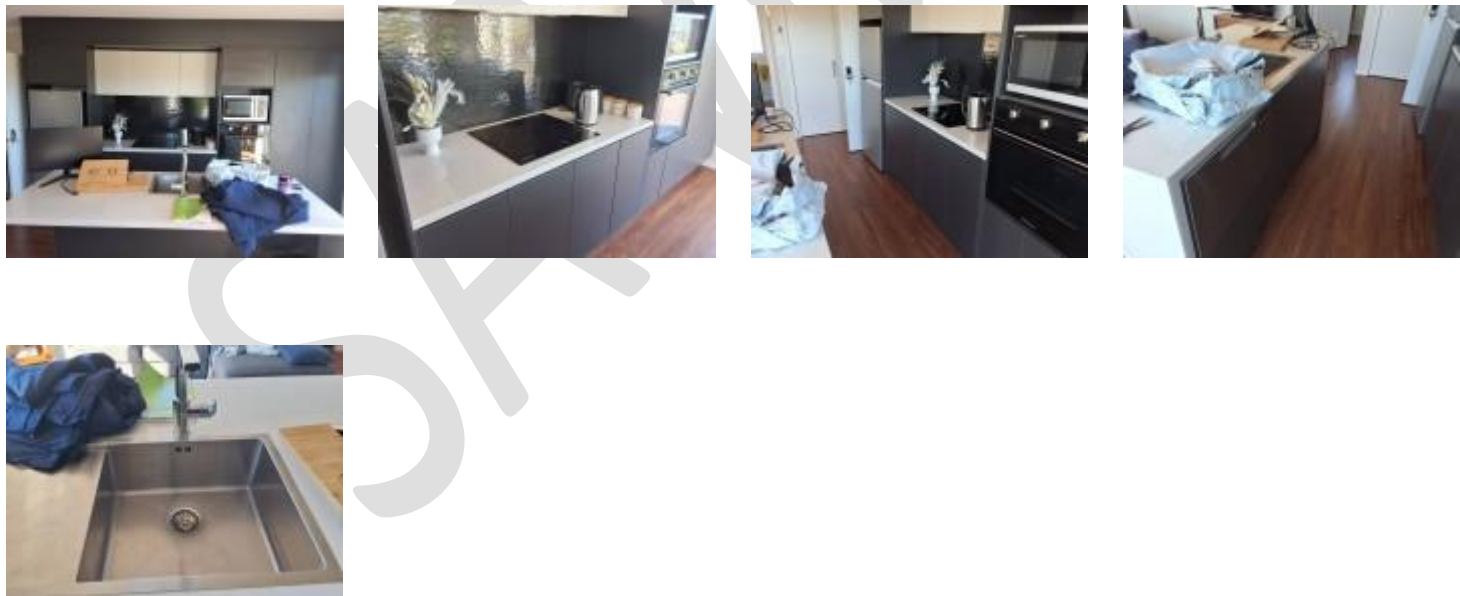
Kitchen 2

Comments	<p>The kitchen is in good working order, with all fixtures and fittings functioning as they should. There are no signs of damage, and no wet areas were detected during the inspection. Everything appears clean, dry, and well-maintained.</p>
----------	---

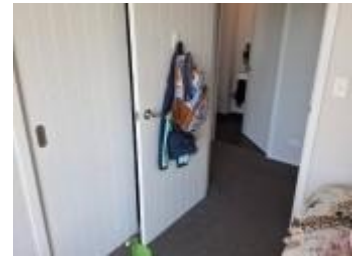
Bed 2

Bedroom 2 is in good condition, with the exterior sliding door and internal door both functioning well. with no moisture detected on the exterior walls.

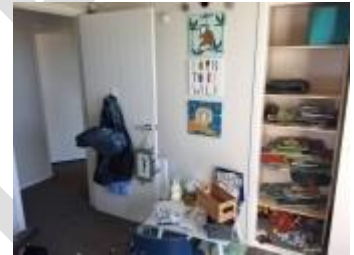
Bed 3

Bedroom 3 is in good condition, with the exterior sliding door and internal door both functioning well. with no moisture detected on the exterior walls.

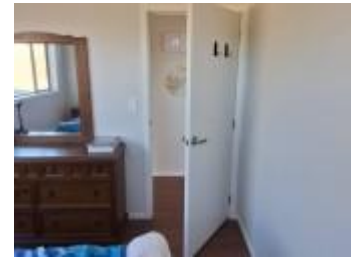
Bed 4

Bedroom 4 is in excellent condition, with no moisture levels detected under the windows. The windows are functioning correctly, and the internal door is in good condition and operates smoothly.

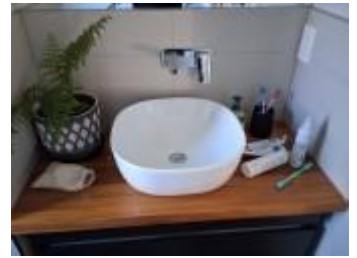
Bathroom 1 is in great condition. The shower was tested and showed no signs of leaks. The tap is functioning well, and the vanity is free from any leaks. The vanity is in good condition, and the exterior window is also working well. Moisture readings around the shower and exterior wall were clear, with no signs of moisture detected.

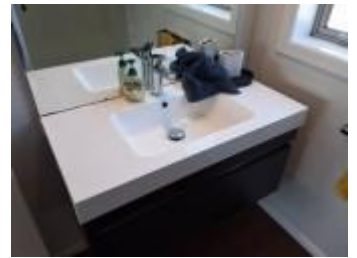
Bathroom 2

The bathroom is in good condition. The shower was checked for leaks and none were found. The window is operational, and the internal door is functioning well. No moisture was detected on the exterior wall or around the toilet and shower areas.

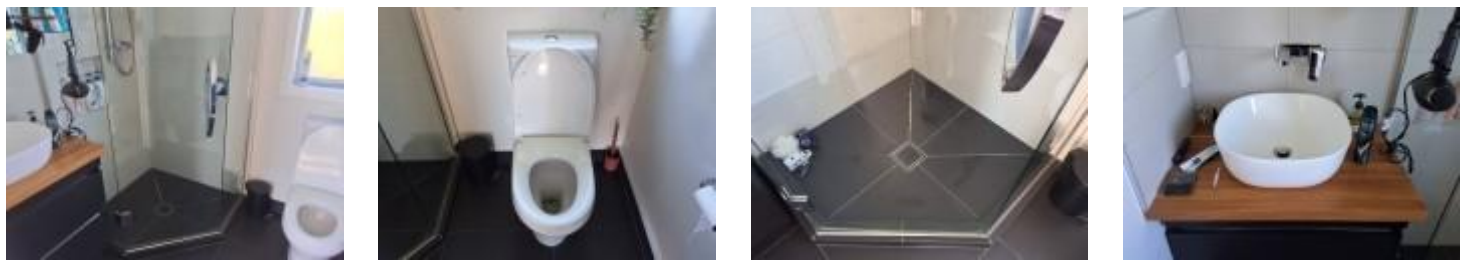
Ensuite

Defect Severity	Minor Defect
Defect Classification	D - Material deterioration (rusting, rotting, corrosion, decay)
Defective Item	Bathroom Shower
Defect	small amount of calcium buildup on shower floor. could be a sign of small amount of water getting under tiles.
Comment	<p>The en-suite is in excellent condition overall, with all fixtures and fittings functioning well. The only minor issue is a small amount of calcium build-up on the grout of the shower floor, which may suggest a small amount of water is getting under the tile.</p> <p>The shower was checked for leaks and none were found. The vanity is in excellent condition with no signs of moisture, and the tap is functioning well. The cavity slider is in excellent condition, and the exterior window is also in good condition. No moisture was detected around the shower or the exterior wall.</p>

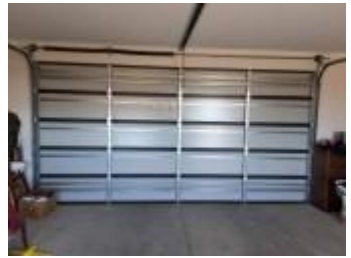
Garage

Defect Severity	Minor Defect
Defect Classification	E - Operational
Defective Item	Doors and Frames
Defect	bottom of aluminum frame under door blocked and potentially holding water.
Comment	The garage is in excellent condition, with the main garage door operating very well. There is a very minor issue with a buildup of debris under the aluminum door at the back of the garage, which appears to be a simple blockage that likely just needs cleaning out.

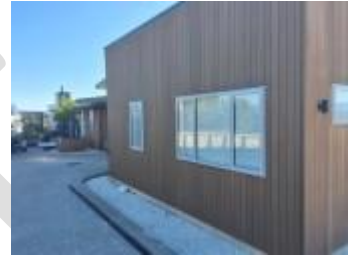
Front Elevation

The front elevations of the house are in excellent condition, with no signs of water damage around the windows, doors, or junctions. The exterior cladding is also in excellent condition, with the cedar well maintained and the fibre cement board showing no issues. Both cladding systems are installed on a cavity system, providing effective drainage and ventilation.

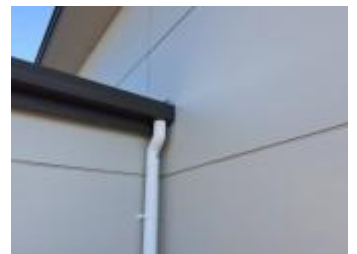
Rear Elevation

The exterior at the back of the house is in excellent condition. The fibre cement board shows no issues, and the cedar cladding has been well maintained. Both cladding systems are installed on a cavity system, and overall maintenance has been kept up to a high standard. The junction forming the veranda appears sound, though ongoing maintenance will be important to prevent potential moisture ingress. Exterior doors and windows are in excellent condition, with no signs of damage or moisture around them.

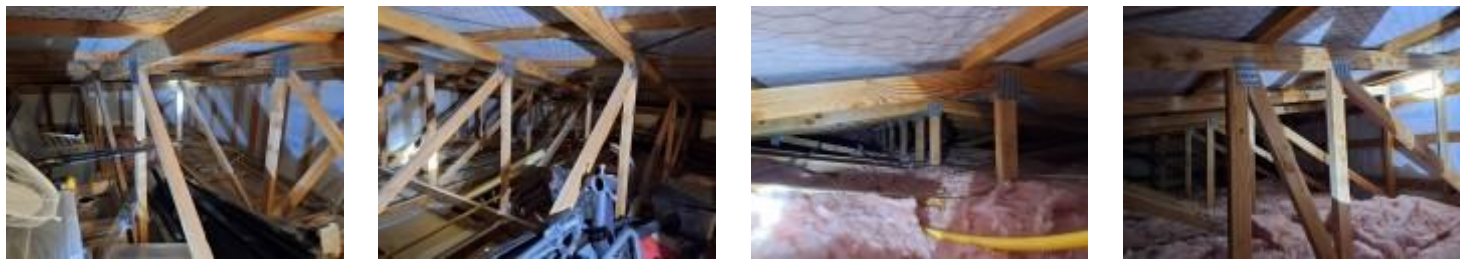
Roof Space

Most of the roof space was accessible, except for the areas with a skillion roof, which provided no access. The roof space above bedrooms 2 and 3 was too shallow to enter, but a photo taken from the manhole shows it to be in excellent condition. The remainder of the roof space that I was able to inspect also appeared to be in excellent condition, with no signs of moisture. Everything was very dry, and the insulation had been well installed.

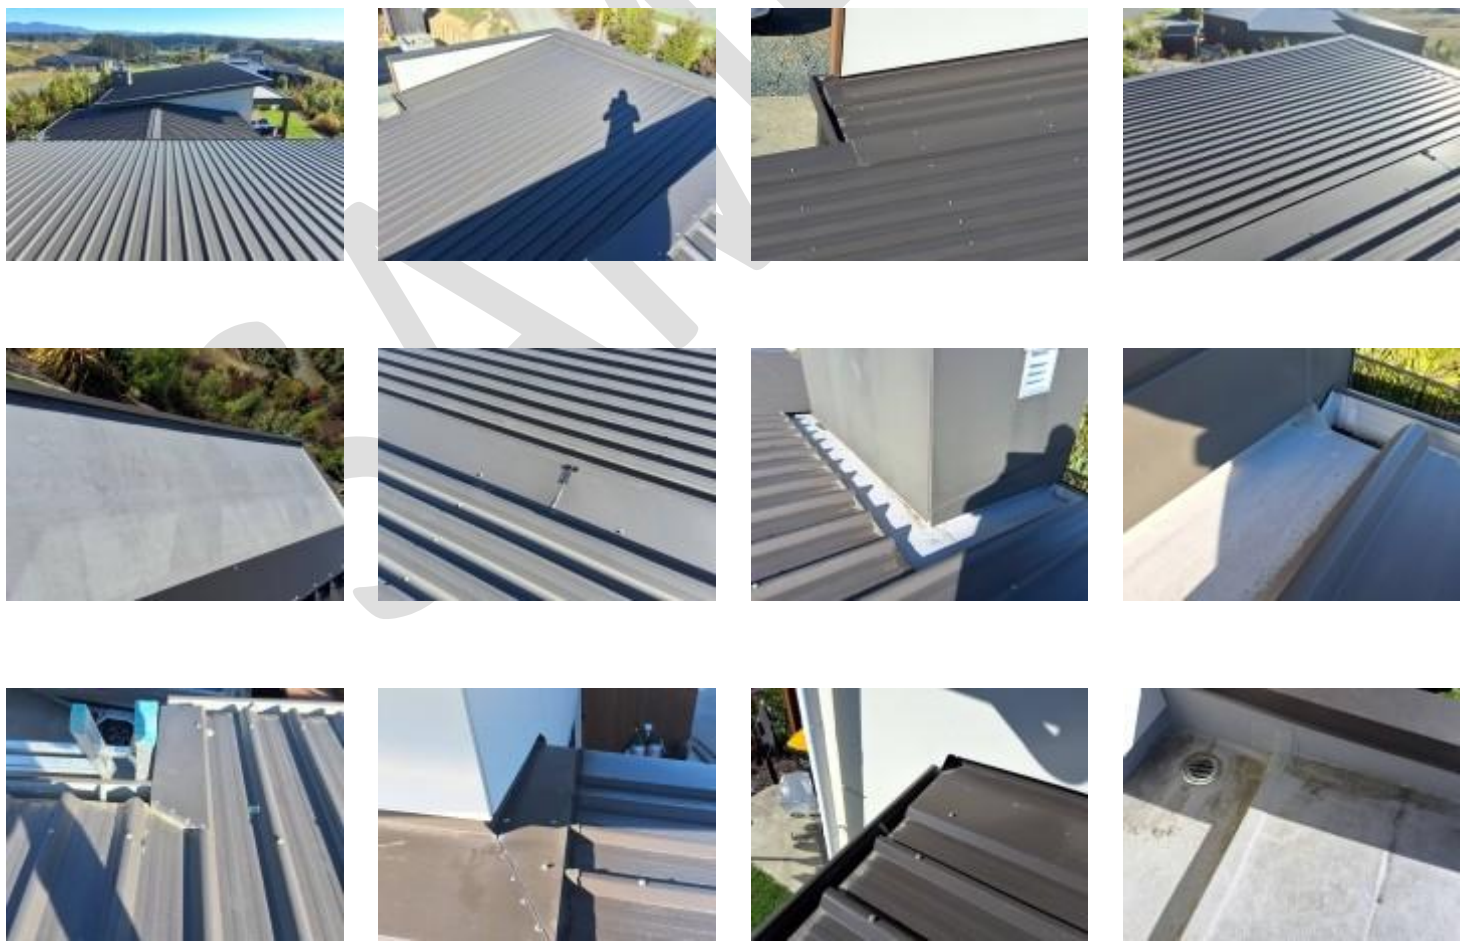
Roof Exterior

Defect Severity	Minor Defect
Defect Classification	D - Material deterioration (rusting, rotting, corrosion, decay)
Defective Item	Barges
Defect	paint peeling on fascia
Comment	<p>The roof is in excellent condition overall. The junctions where the roof meets the cladding have been constructed with precision and include well-designed diverters that direct water efficiently into the gutters. The membrane roofing has been expertly installed, with no visible signs of water damage. Water drains away effectively, with no evidence of pooling. Both internal drains on the veranda's membrane roof are clear and appear to be functioning very well.</p> <p>The only very minor defect observed is a small amount of paint cracking on the fascia, which is not a cause for concern and can be easily remedied.</p>
